**Watershed Assessment**  
**Bjerkness, Lofstedt and Fletcher Creeks**

**Prepared for**  
**Appropriate Forestry Services Ltd. and**  
**Goose Creek Lumber Ltd.**

**June 20, 2000**

**by**  
**David J. Putt P. Geo., P. Ag.**  
**Forterra Consultants Ltd.**  
**and**  
**Martin Carver, P. Eng., P. Ag.**  
**Martin Carver Consulting**

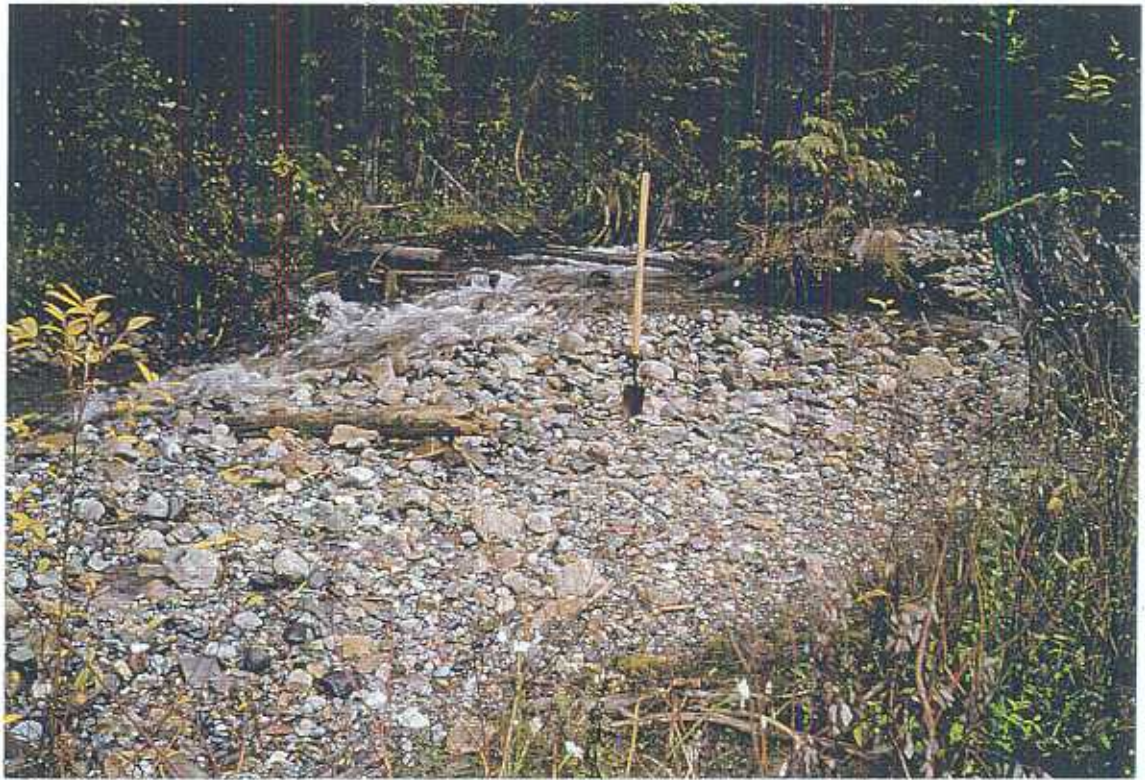
Figure 5 – Bjerkness Ck. Reach 1 – just above the POI. Extensive bar area

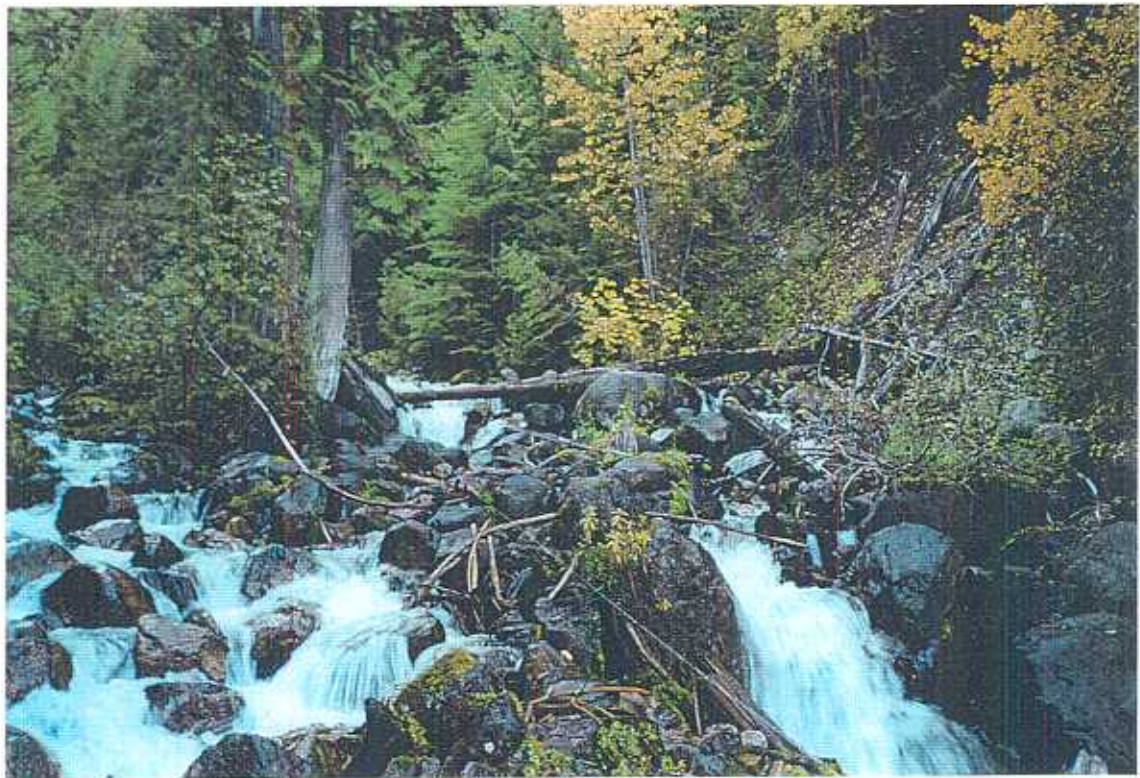
This reach is characterized by a downstream accumulation of large lag boulders (secondary axis > 1 m in width) with a significant input of much finer sediment from landslides throughout the length of the reach. This reach is wider and steeper than reach 4 and is highly coupled to the unstable sidewalls. A total of seventeen slides was observed adjacent to the channel, most of which delivered 100% of their original volume into the creek. It appeared that the majority was caused by the old road immediately upslope of the north bank. Mid-way down the reach, sediment wedges are commonplace and there is a fining of their texture, especially in the subsurface, suggesting an abundance of material for transport. This abundant sediment (gravels and small cobbles) has infilled many of the pools, limiting their extent. The huge early post-glacial lag material in the upper part of the reach, in conjunction with the steep channel gradient, serve to limit the impact of the finer sediment supply in the lower 400-500 m. Wood is not an important channel component in the lower reach because the channel morphology is defined by the large lag material present. (See photo, Figure 6.)

Figure 6 Bjerkness Creek, Reach 3 – 1+810m. Large lag boulder dominated channel. Note small slide on north bank

- Field review the active landslides in reaches 3 and 4 to determine if they can be rehabilitated using bioengineering techniques. As noted earlier some of the slides, including the largest one noted, are natural and it is unlikely that they can be effectively stabilized. However, some of the development related slides on the north side of the creek may be amenable to control. Road deactivation and slide rehabilitation will significantly reduce the sediment inputs to the creek and consequently, over time, reduce the flooding risk.

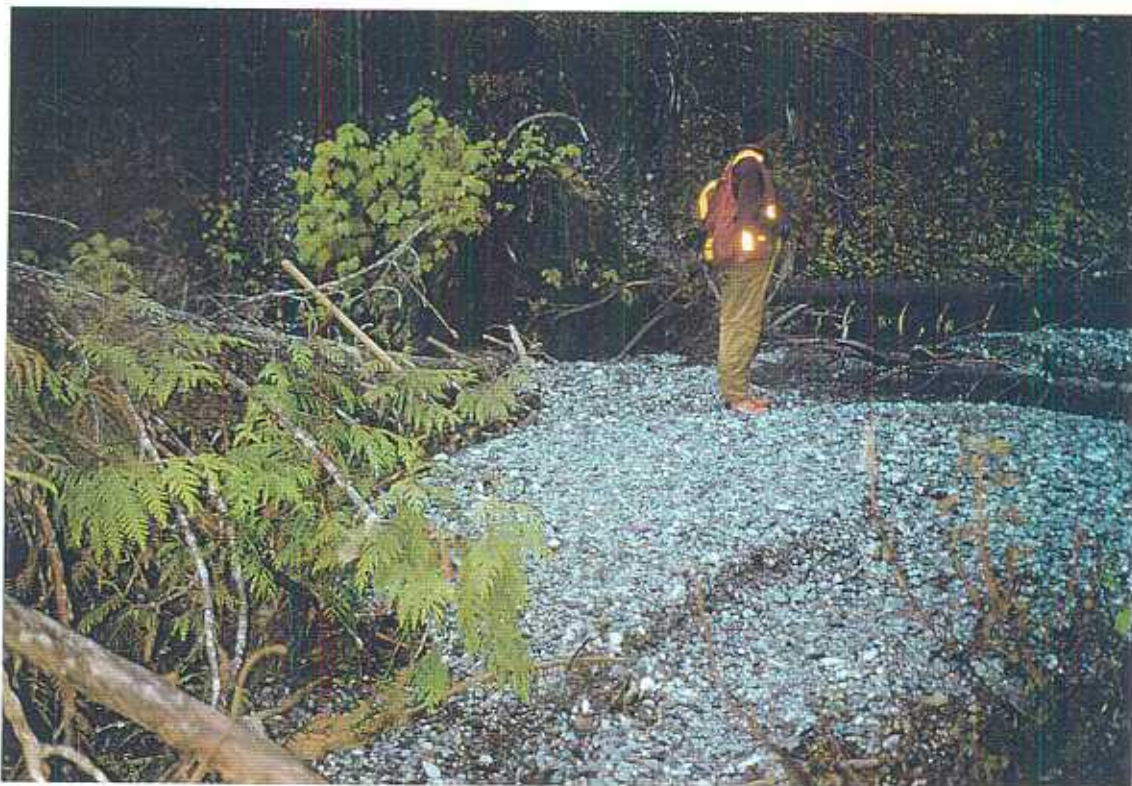
Figure 7 – Bjerkness Ck. Reach 5 – 3+390. Aggraded section with large sediment wedge

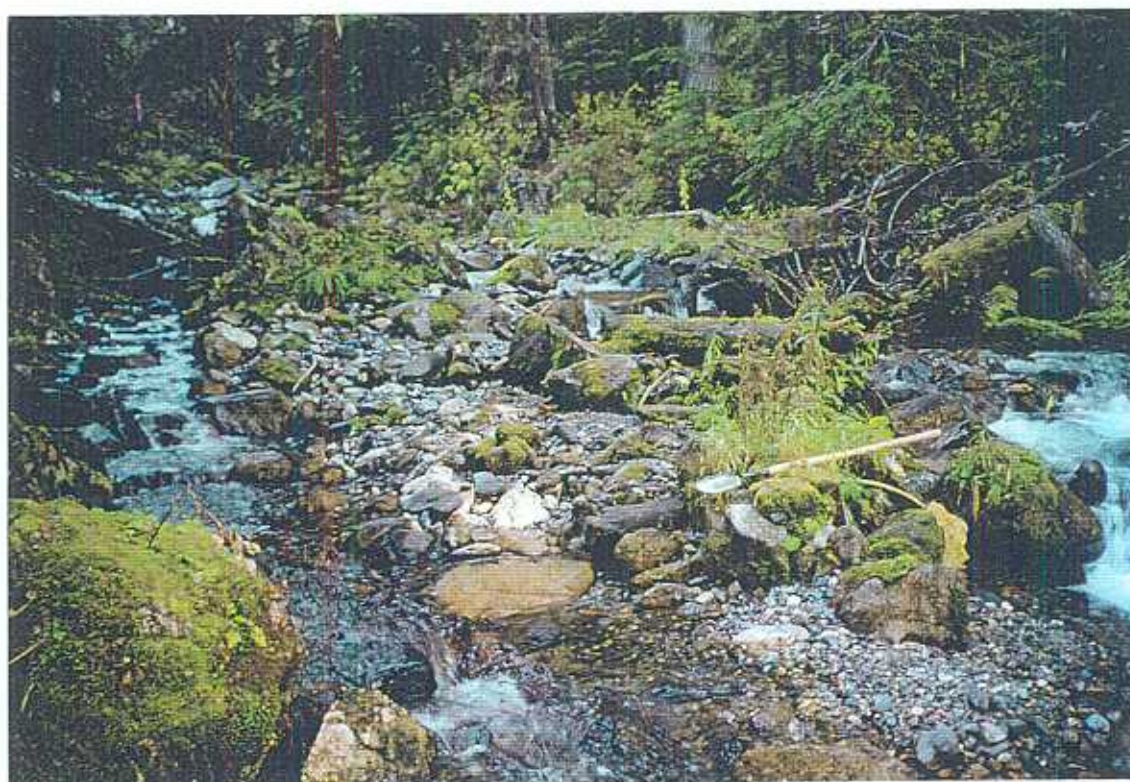
This step-pool/cascade reach shows signs of a major past disturbance in addition to contemporary disturbance, with both aggradation and degradation. In the top half of the reach, extensive scour, an absence of functioning wood, and diminished pool areas highlight the degradation present. In the bottom half of the reach, aggradation characteristics include a reduction in step frequency and step stability, and extensive bars. There is evidence of recovery from a major flood event 30+ years ago both in terms of large off-channel woody debris piles and vegetating elevated mid-channel bars (see photo, Figure 8). Signs of disturbance remain sufficiently modest to see stone lines, moderate-to-good pool extent, and moderate functioning wood. Large lag boulders provide important bed/step stability and are likely related to major debris flow events 200-400 years ago.

Figure 8 Bjerkness Creek, Reach 6 – 4+590m. Recovering bars.

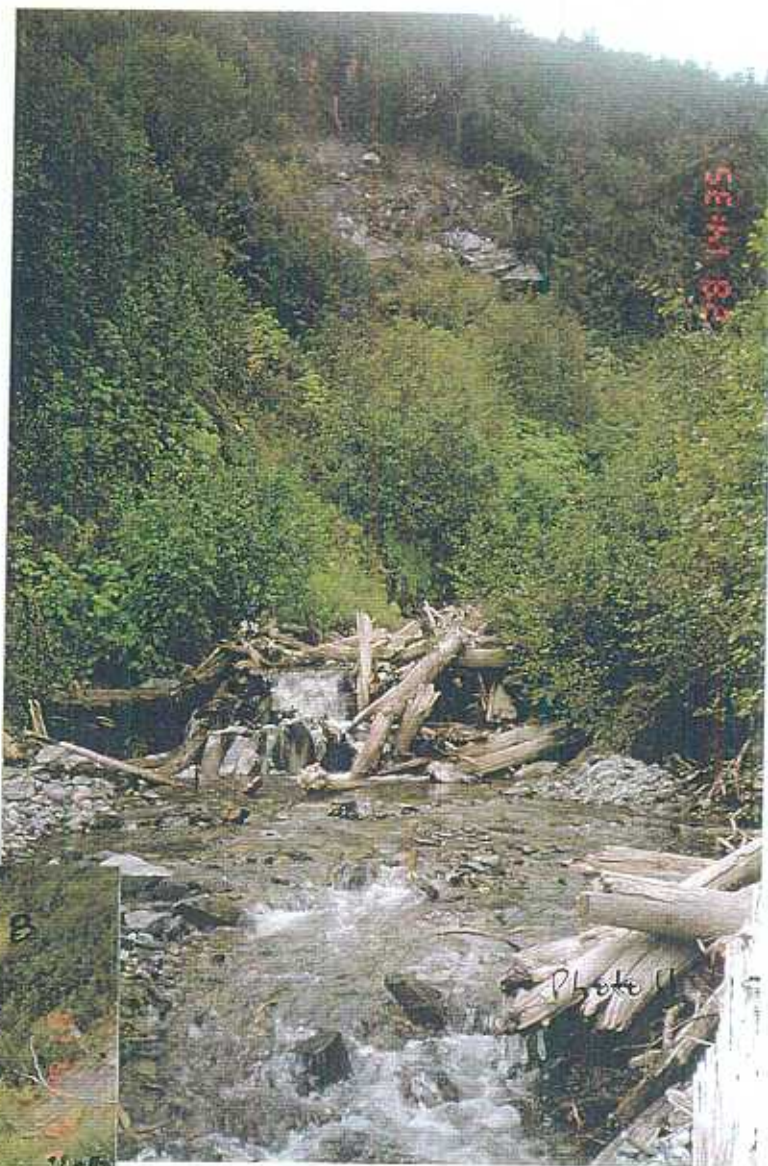
Figure 9  
Bjerkness Ck. - 5+207  
Old woody debris jam. Note  
extensive bars and landslide  
scar in background (slide is  
not numbered – little  
sediment delivery to creek)

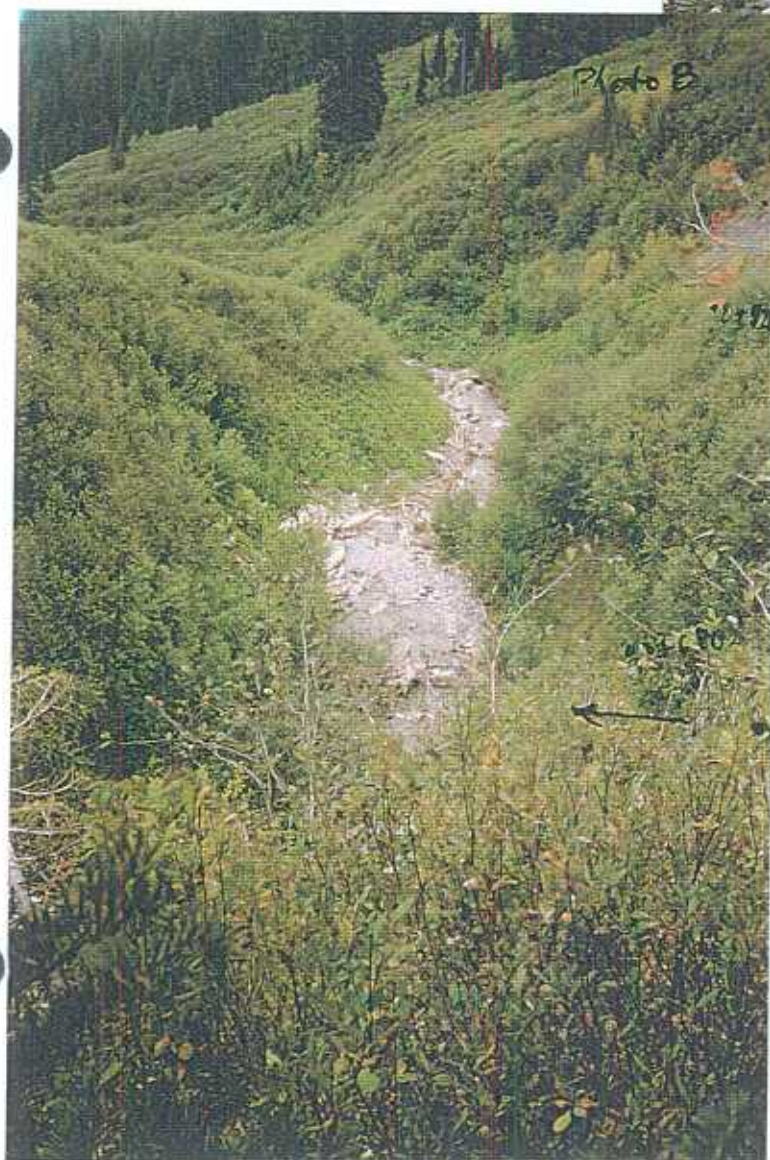
Figure 10 Bjerkness Creek  
Reach 7 – 5+150 to 5+400  
Extensive bars and large  
amounts of woody debris.  
Unnumbered landslide in  
background, landslide No. 35  
in foreground

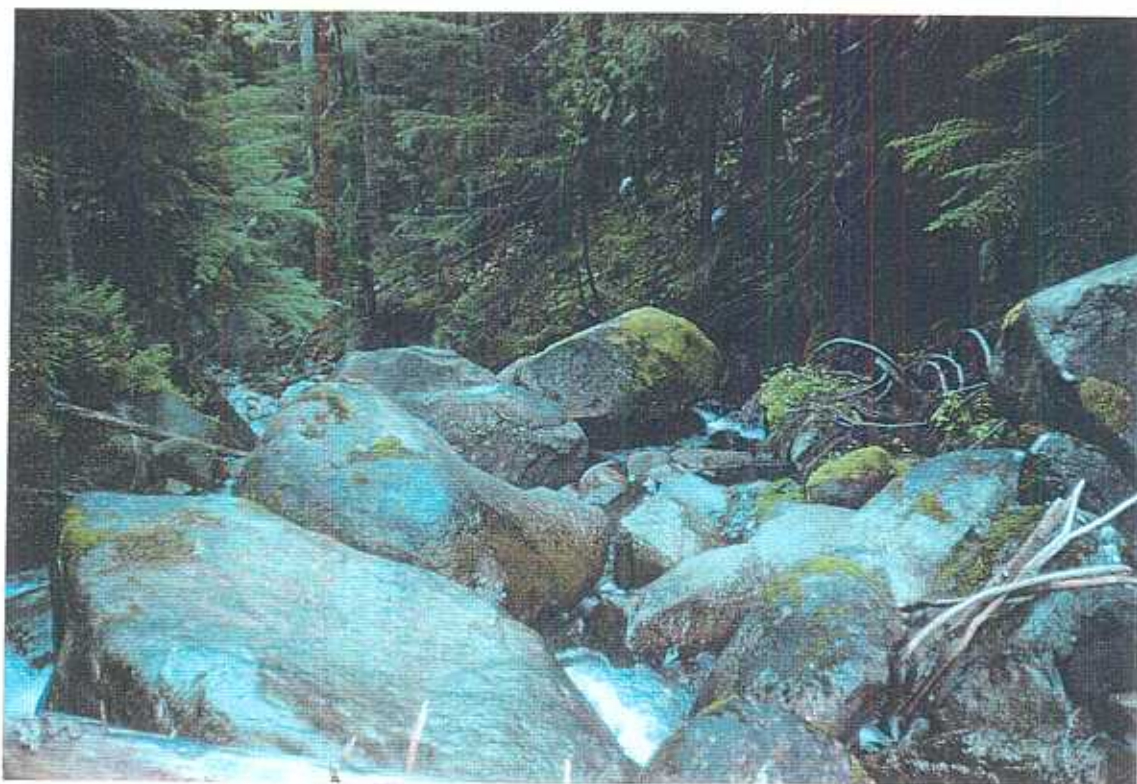
Figure 11 Fletcher Ck. Reach 3 – 1+975. Large lag boulder dominated channel

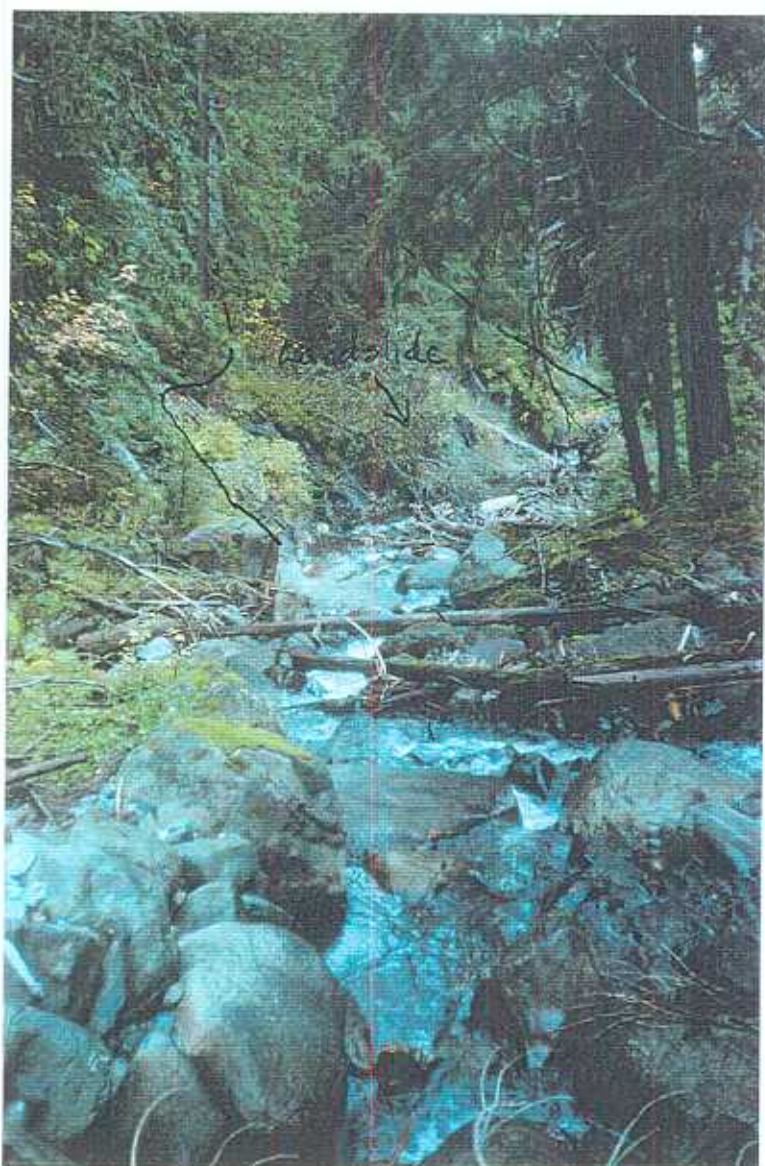
Figure 12 Fletcher Creek  
Reach 5 - 2+824  
Lag boulder dominated  
channel in foreground. Slide  
No. 5 in background – note  
erosion at toe of slide

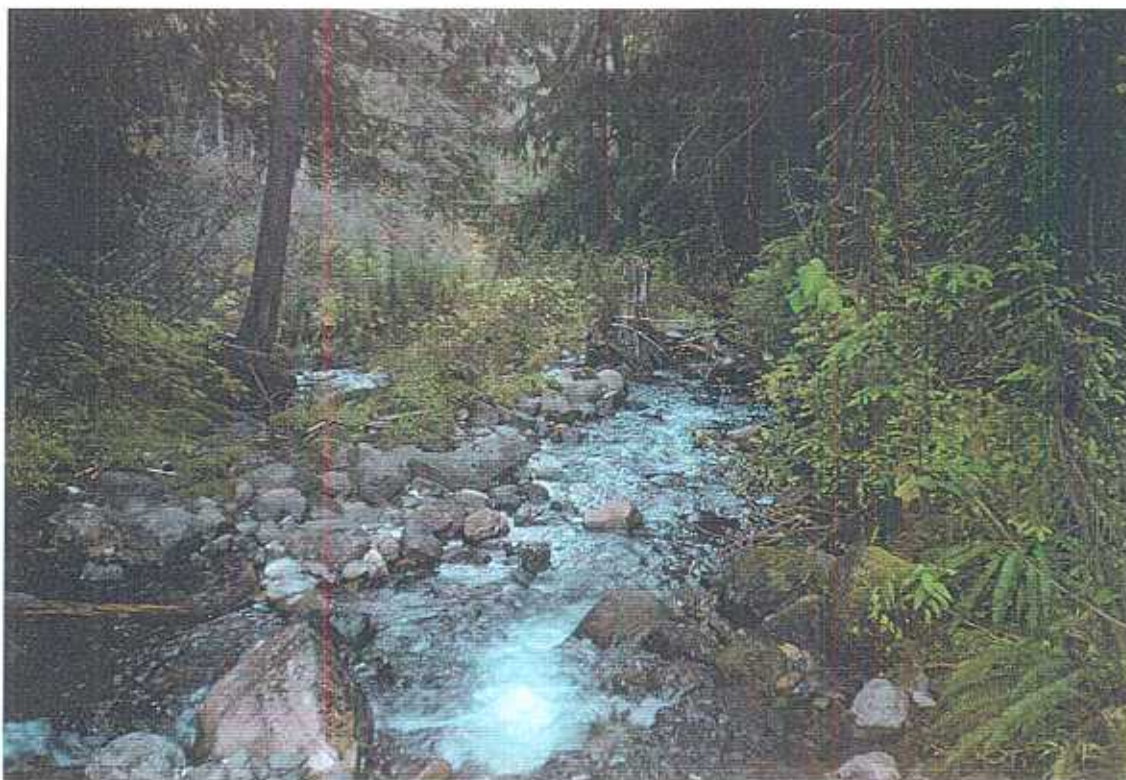
Figure 13 Fletcher Ck. Reach 5 – 2+943. Aggraded channel. Note revegetation on mid channel bar

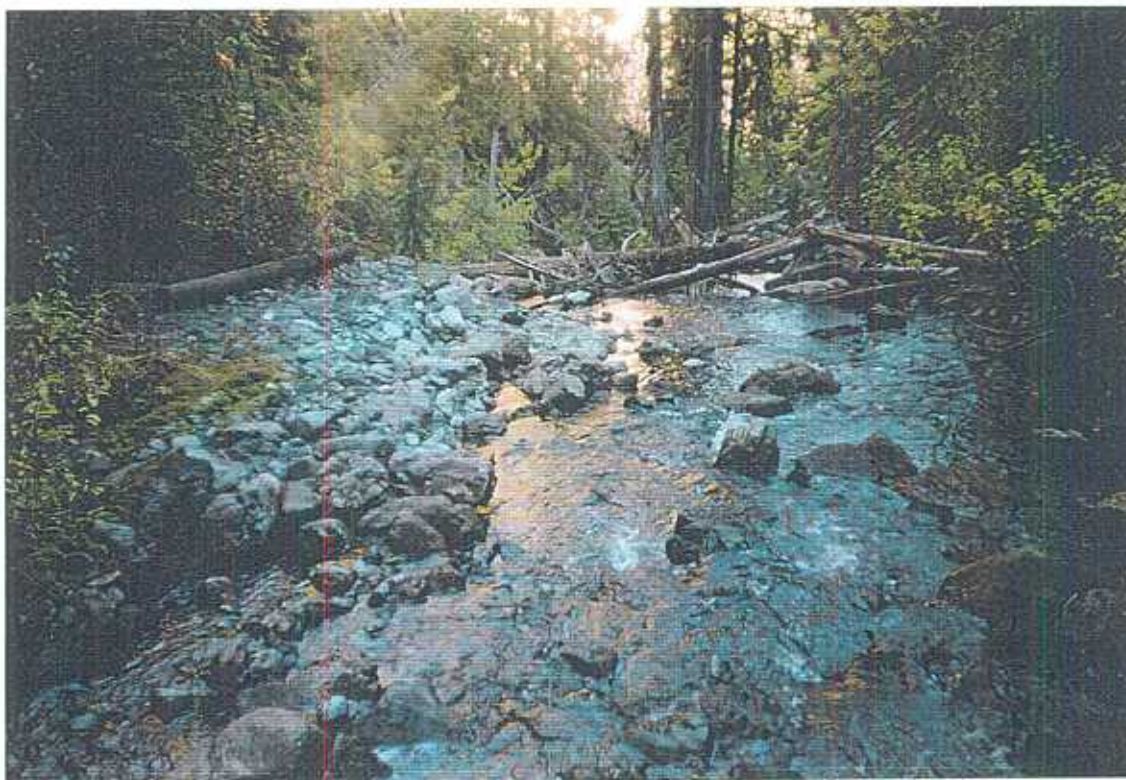
Figure 14 Fletcher Creek, Reach 6 – 3+443. Aggraded section – material is from landslide No 17.
