Zwicky Road Landslide Site Assessment, Kaslo, BC, 18 April 2017

Sarah Crookshanks, P.Geo. (MFLNRO)

Peter Jordan, P.Geo. (SNT Geotechnical Ltd.)

April 20, 2017

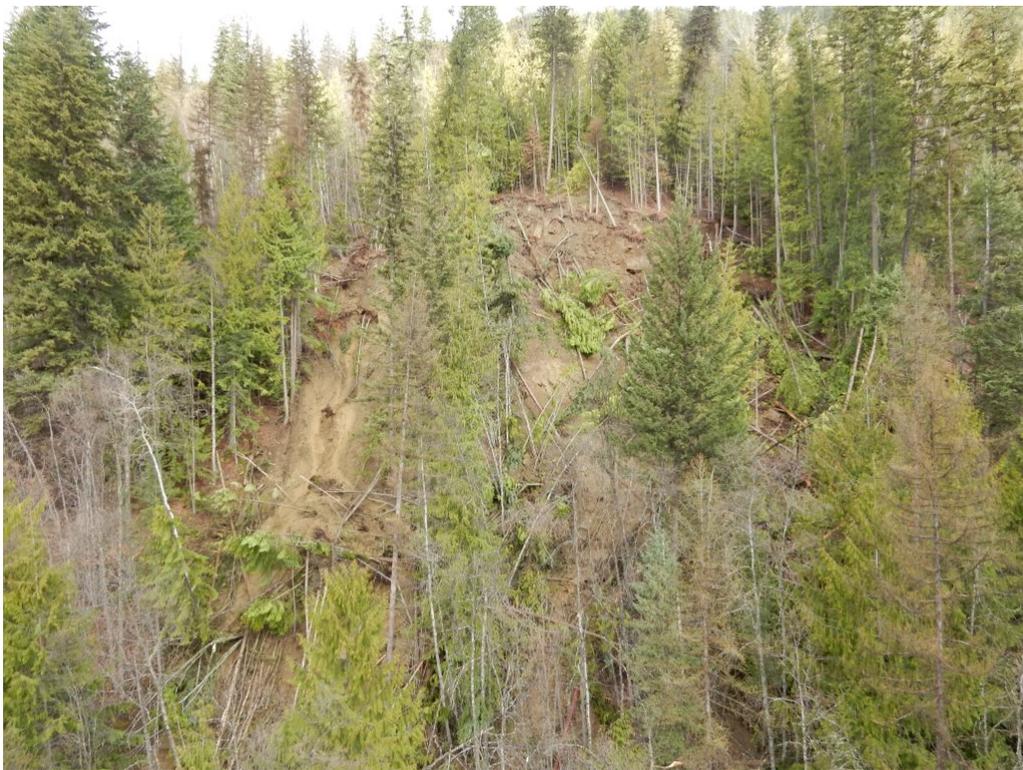
Figure 3. View of the landslide from the helicopter.

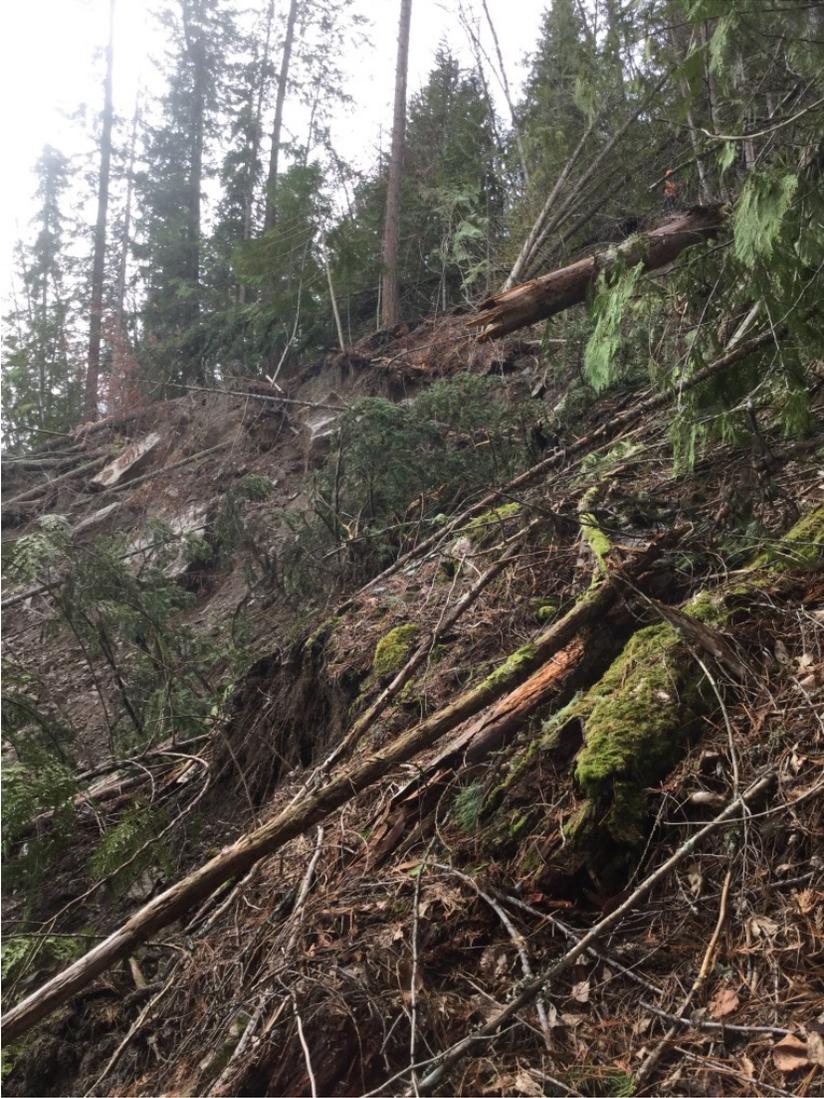
Figure 4. View across the slide from the northeast edge near the headscarp.

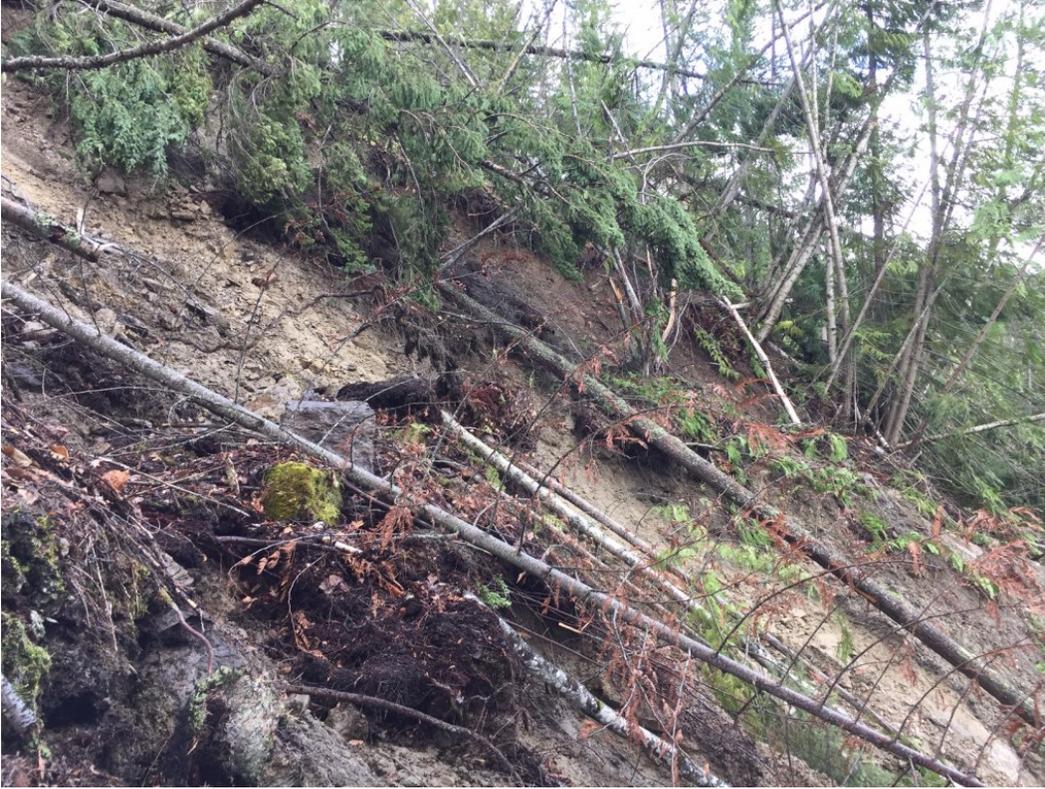
Figure 5. View across the slide from the southwestern edge.

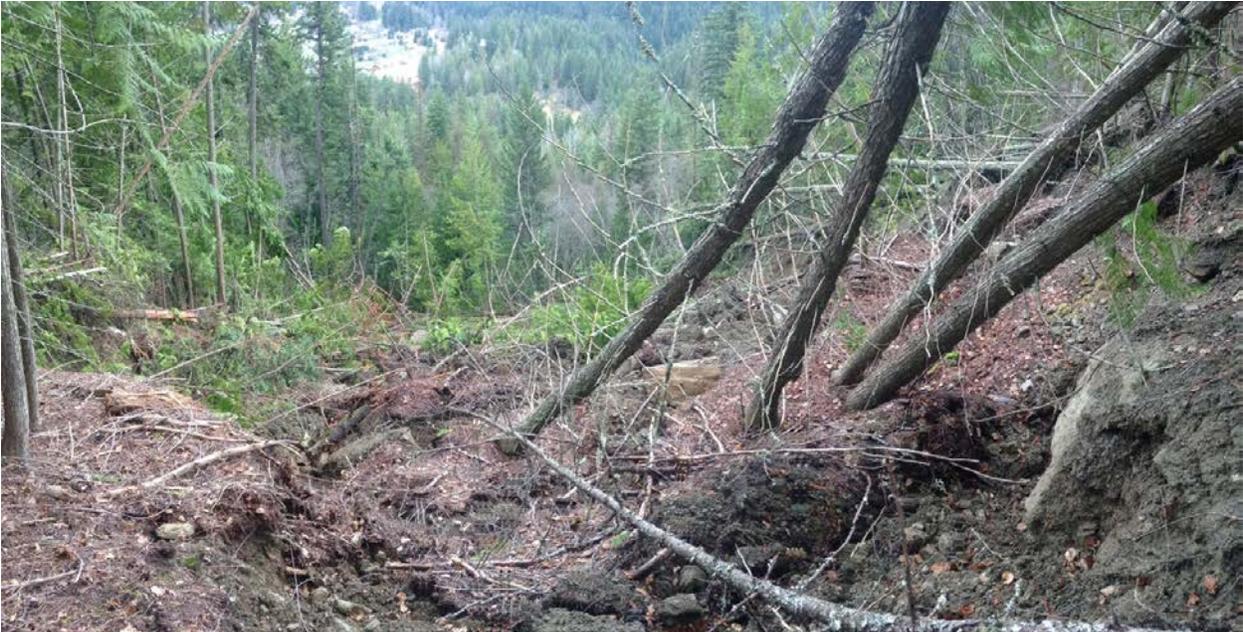
Figure 6. View down the slide from above the headscarp (photo credit: Brad Panton).

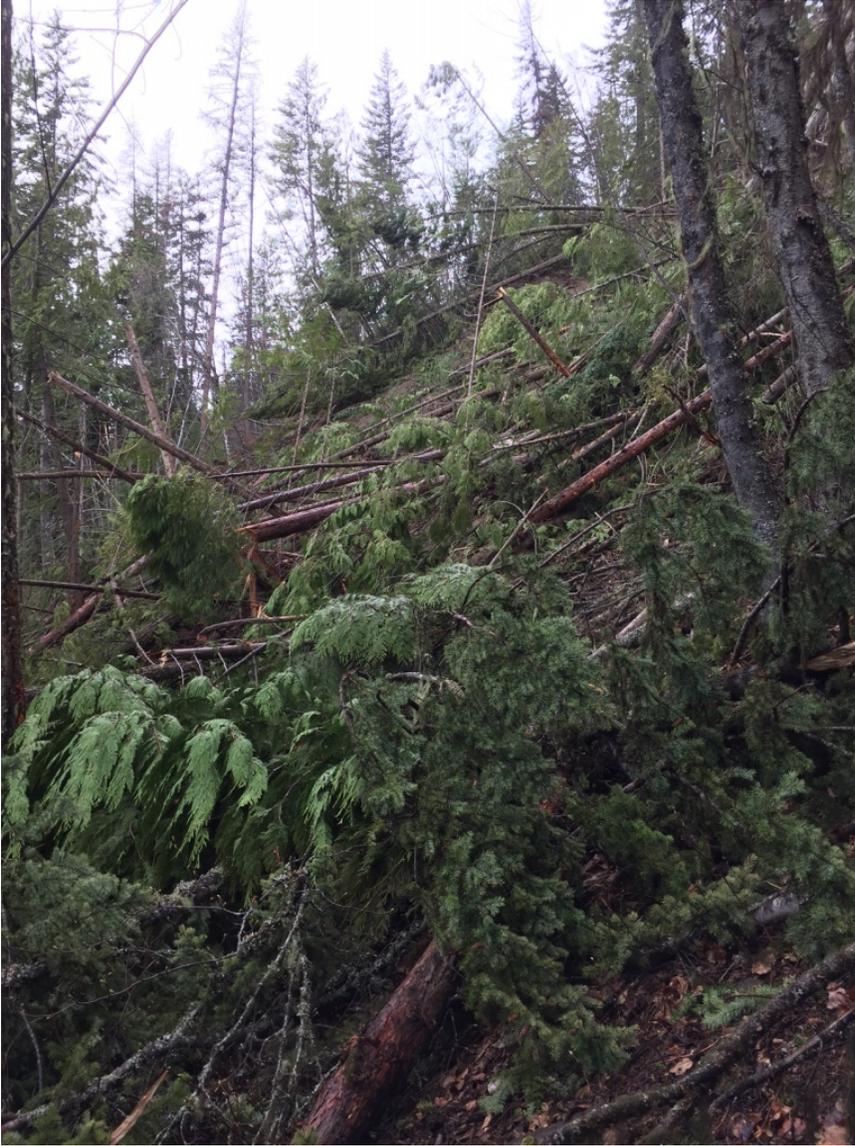
Figure 7. View across the slide path from the bottom of the northeastern edge.
