**Watershed Assessment**  
**Bjerkness, Lofstedt and Fletcher Creeks**

**Prepared for**  
**Appropriate Forestry Services Ltd. and**  
**Goose Creek Lumber Ltd.**

**June 20, 2000**

**by**  
**David J. Putt P. Geo., P. Ag.**  
**Forterra Consultants Ltd.**  
**and**  
**Martin Carver, P. Eng., P. Ag.**  
**Martin Carver Consulting**

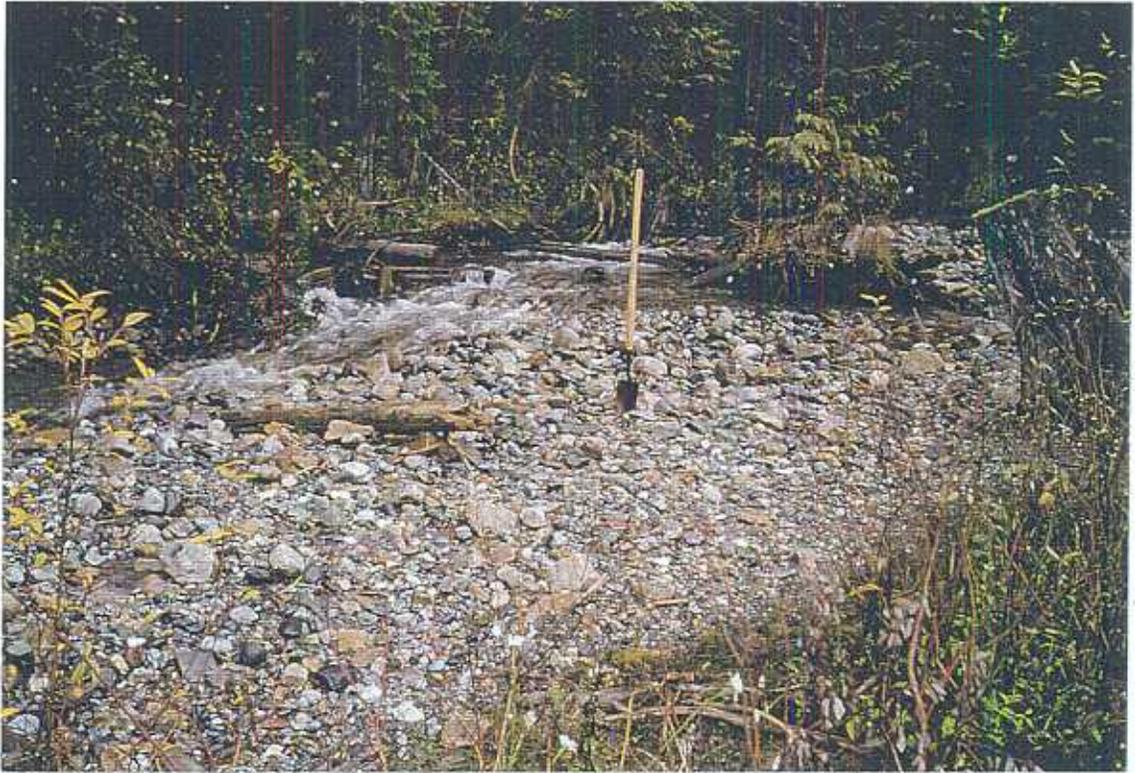
Figure 5 – Bjerkness Ck. Reach 1 – just above the POI. Extensive bar area

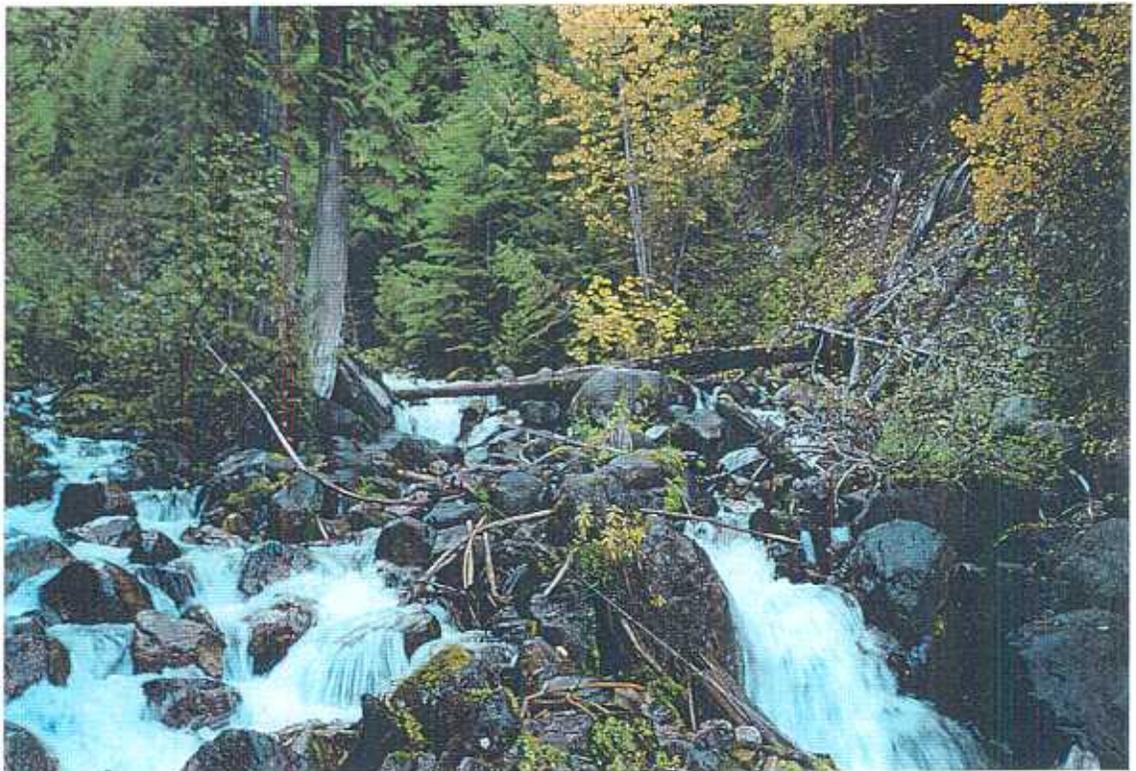
This reach is characterized by a downstream accumulation of large lag boulders (secondary axis > 1 m in width) with a significant input of much finer sediment from landslides throughout the length of the reach. This reach is wider and steeper than reach 4 and is highly coupled to the unstable sidewalls. A total of seventeen slides was observed adjacent to the channel, most of which delivered 100% of their original volume into the creek. It appeared that the majority was caused by the old road immediately upslope of the north bank. Mid-way down the reach, sediment wedges are commonplace and there is a fining of their texture, especially in the subsurface, suggesting an abundance of material for transport. This abundant sediment (gravels and small cobbles) has infilled many of the pools, limiting their extent. The huge early post-glacial lag material in the upper part of the reach, in conjunction with the steep channel gradient, serve to limit the impact of the finer sediment supply in the lower 400-500 m. Wood is not an important channel component in the lower reach because the channel morphology is defined by the large lag material present. (See photo, Figure 6.)

Figure 6 Bjerkness Creek, Reach 3 – 1+810m. Large lag boulder dominated channel. Note small slide on north bank

- Field review the active landslides in reaches 3 and 4 to determine if they can be rehabilitated using bioengineering techniques. As noted earlier some of the slides, including the largest one noted, are natural and it is unlikely that they can be effectively stabilized. However, some of the development related slides on the north side of the creek may be amenable to control. Road deactivation and slide rehabilitation will significantly reduce the sediment inputs to the creek and consequently, over time, reduce the flooding risk.

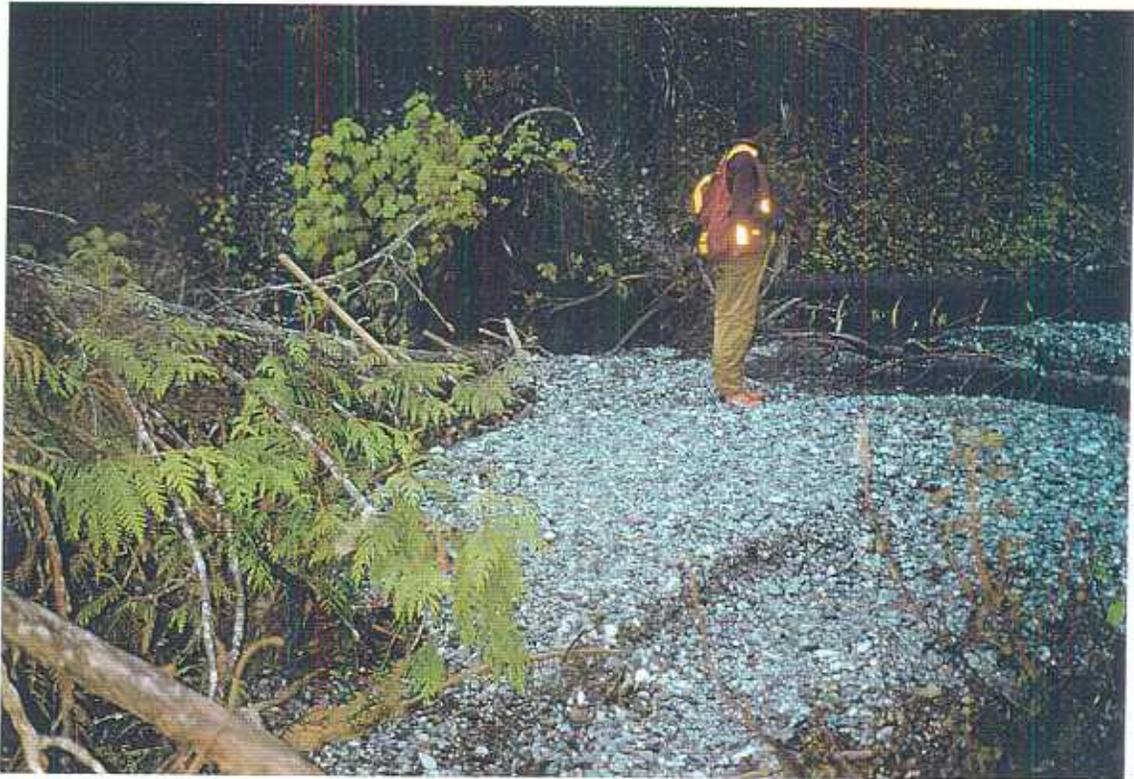
Figure 7 – Bjerkness Ck. Reach 5 – 3+390. Aggraded section with large sediment wedge

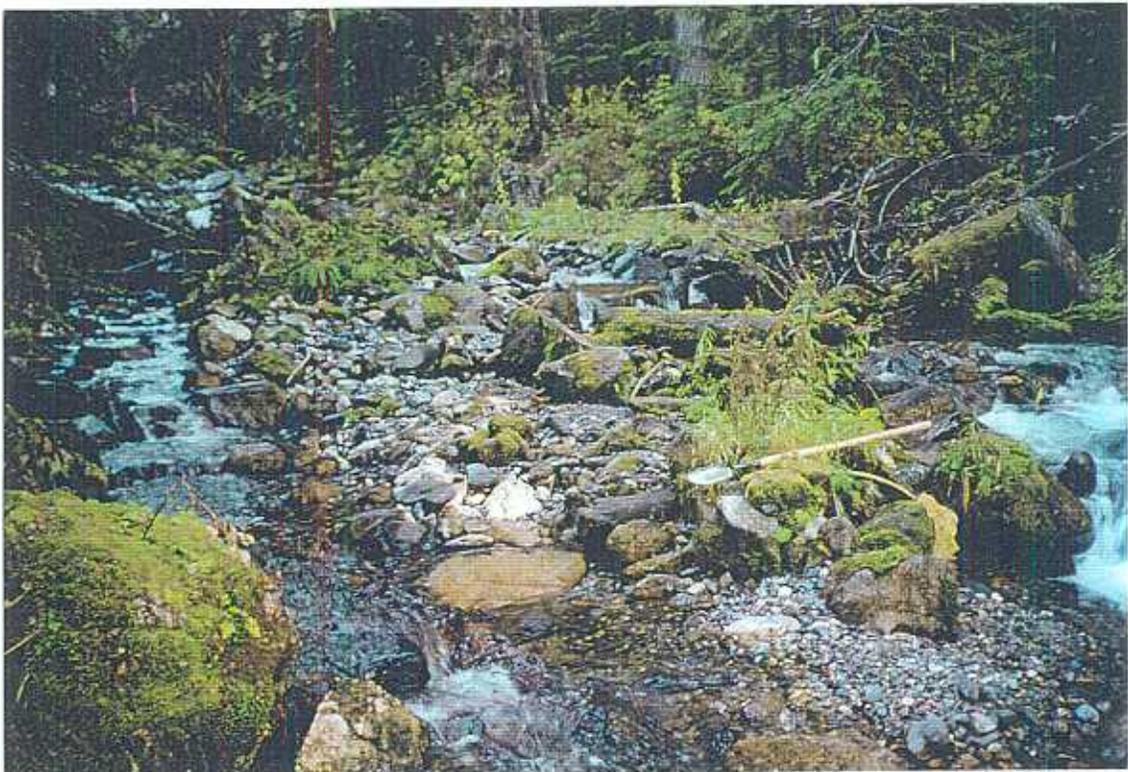
Figure 8 Bjerkness Creek, Reach 6 – 4+590m. Recovering bars.

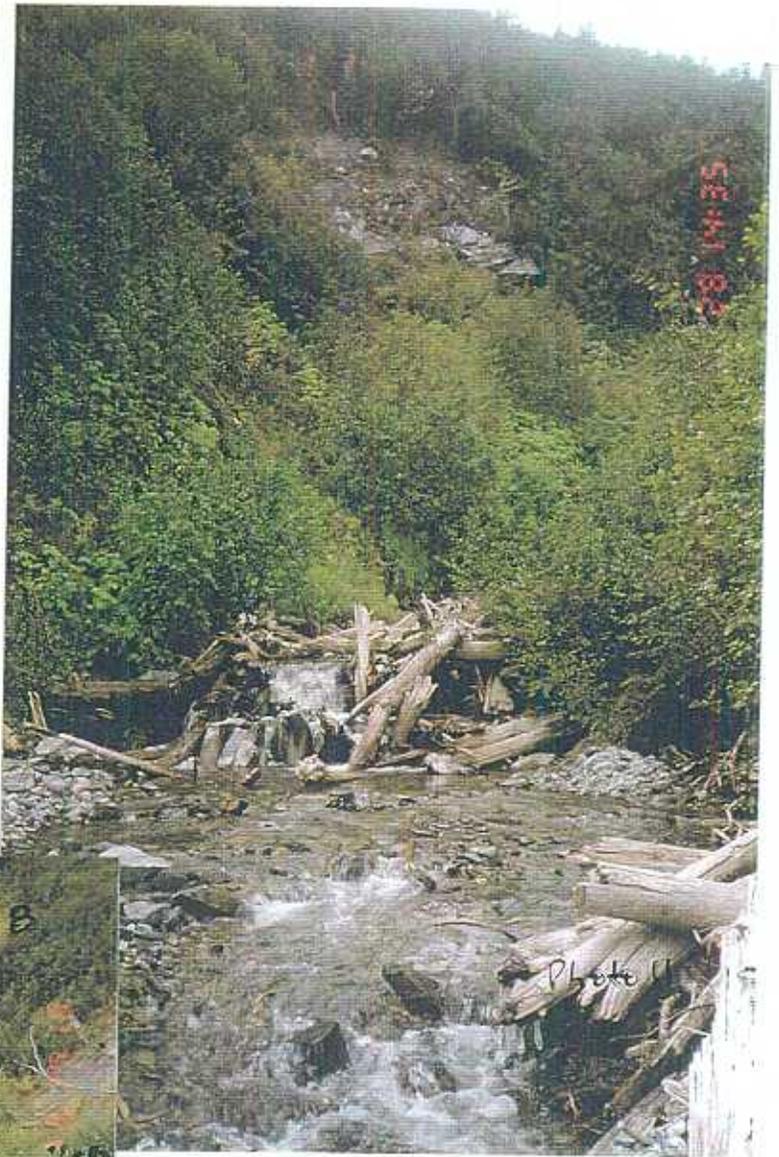
Figure 9  
Bjerkness Ck. - 5+207  
Old woody debris jam. Note  
extensive bars and landslide  
scar in background (slide is  
not numbered – little  
sediment delivery to creek)

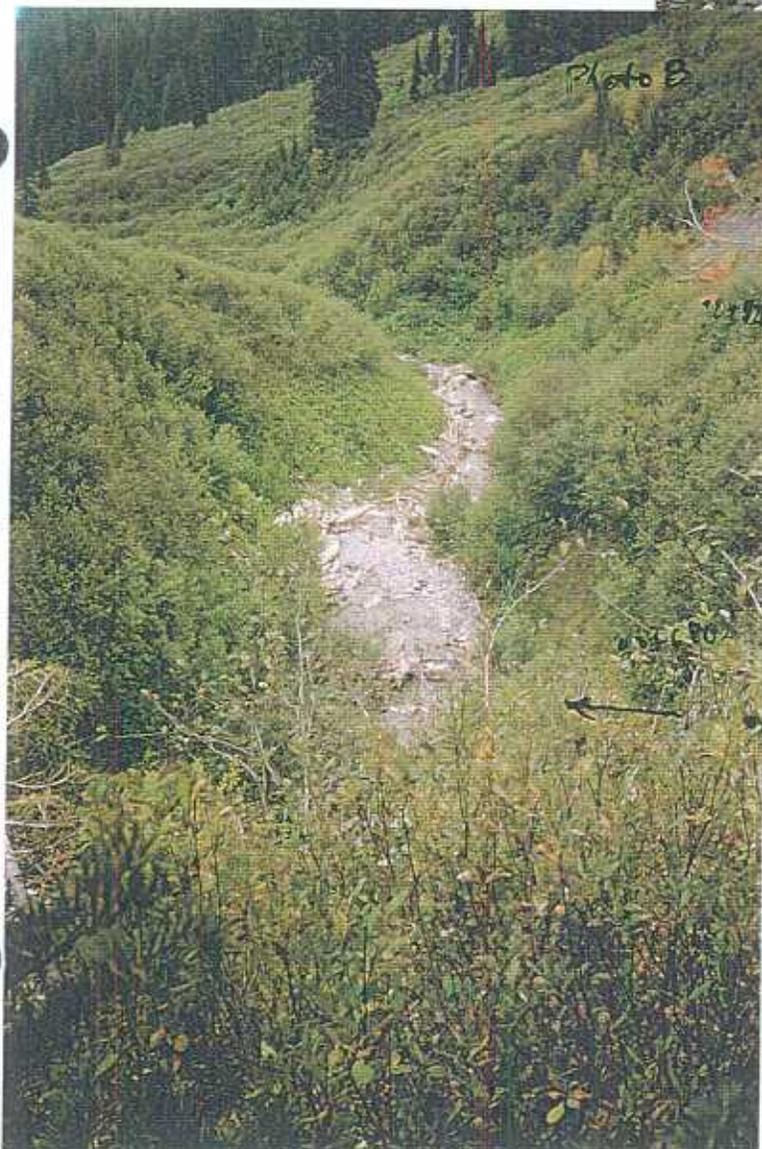
Figure 10 Bjerkness Creek  
Reach 7 – 5+150 to 5+400  
Extensive bars and large  
amounts of woody debris.  
Unnumbered landslide in  
background, landslide No. 35  
in foreground

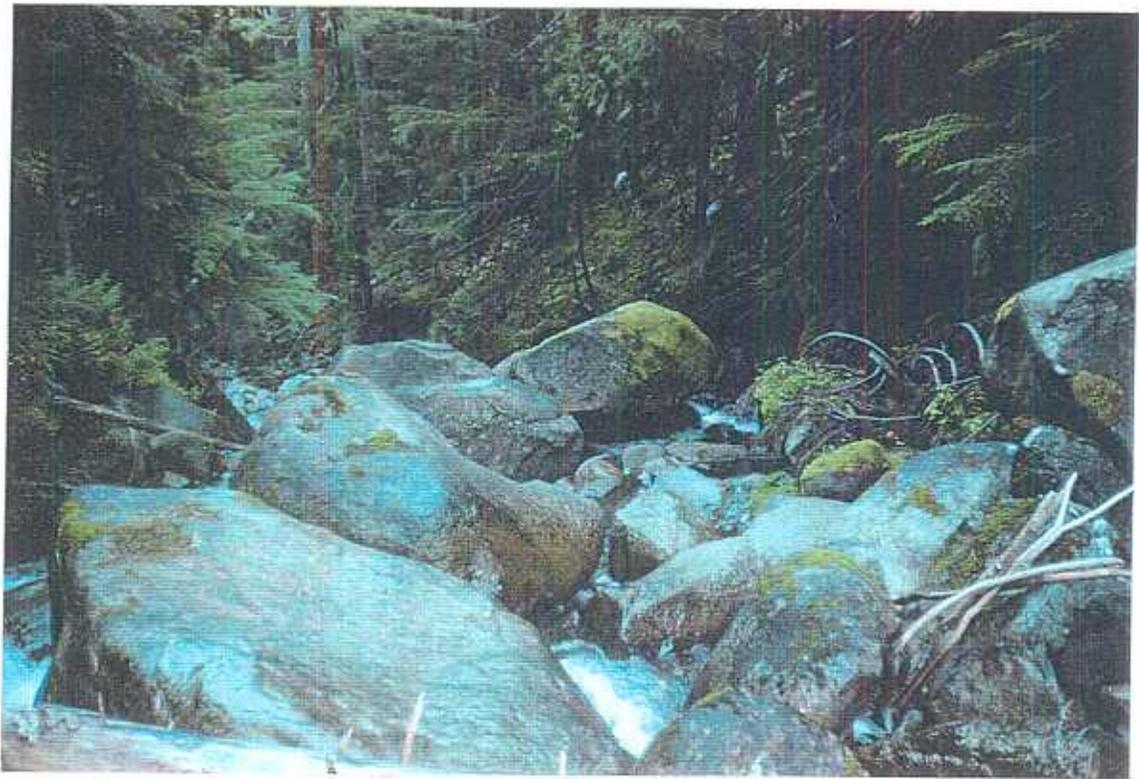
Figure 11 Fletcher Ck. Reach 3 – 1+975. Large lag boulder dominated channel

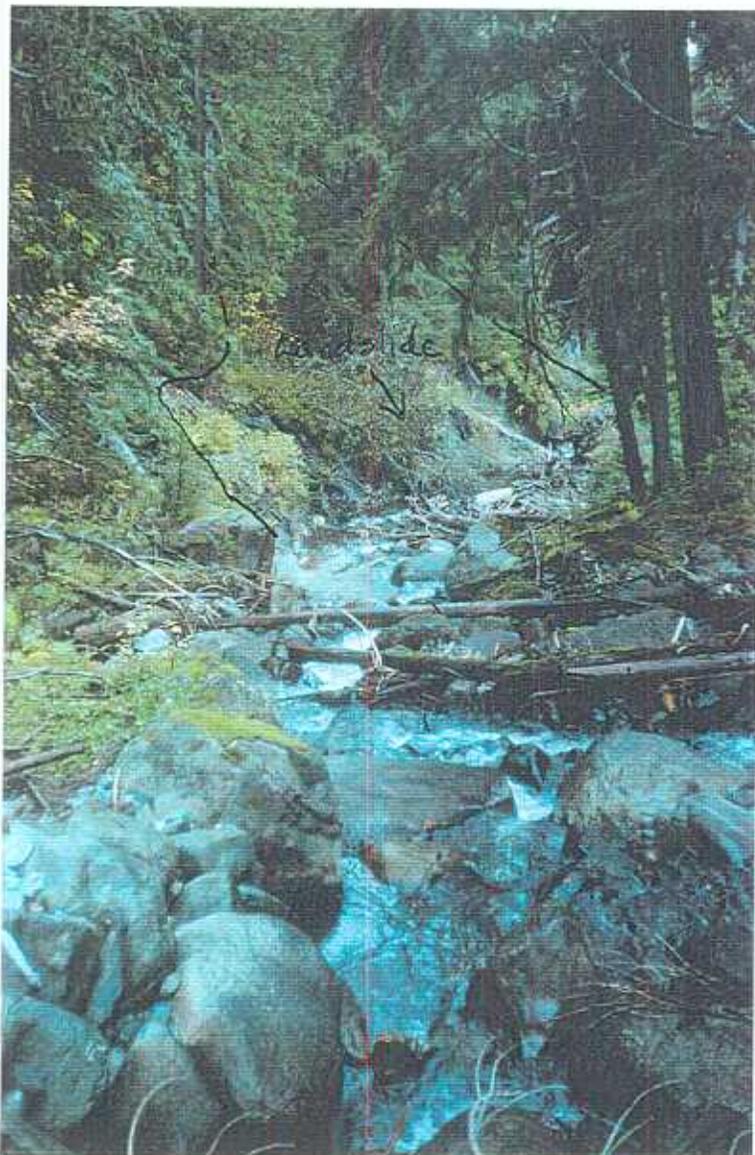
Figure 12 Fletcher Creek  
Reach 5 - 2+824  
Lag boulder dominated  
channel in foreground. Slide  
No. 5 in background – note  
erosion at toe of slide

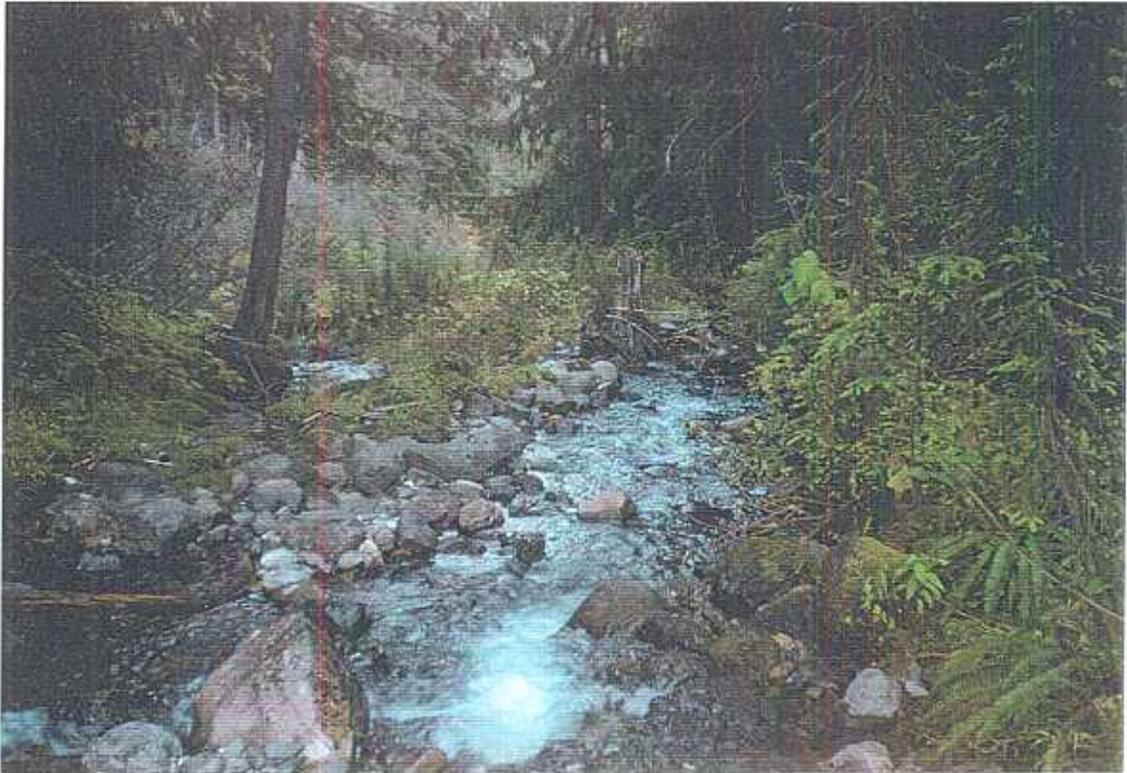
Figure 13 Fletcher Ck. Reach 5 – 2+943. Aggraded channel. Note revegetation on mid channel bar

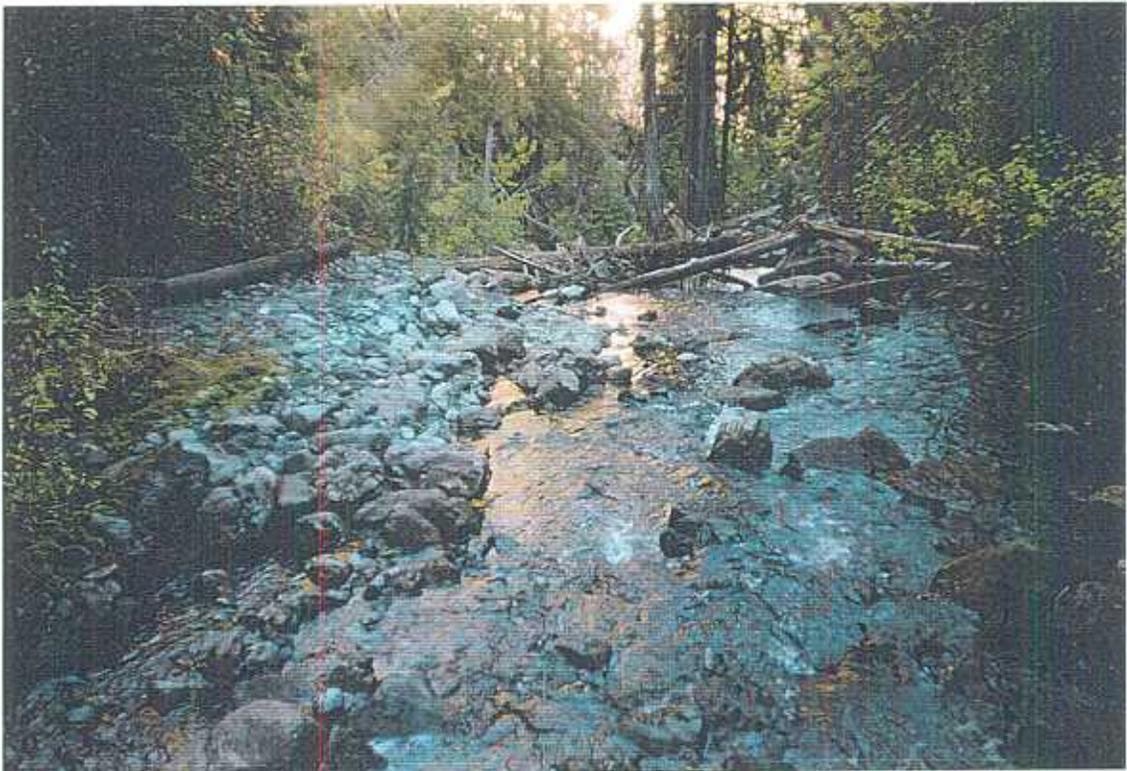
Figure 14 Fletcher Creek, Reach 6 – 3+443. Aggraded section – material is from landslide No 17.
