TECHNICAL MEMORANDUM

Date: January 28, 2019 **FILE:** SCL 18-1465

Subject: Bjerkness Road – Drainage Control
Bjerkness Creek, Kaslo, B.C.

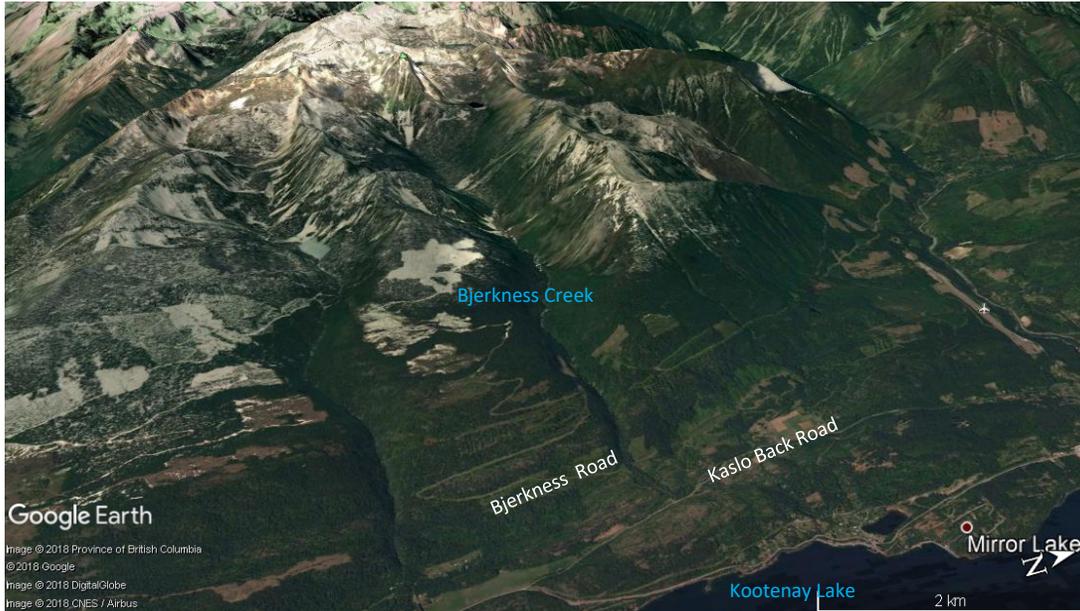
Image 1: Oblique aerial view using GE looking west at the Bjerkness drainage located above the Community of Mirror Lake.

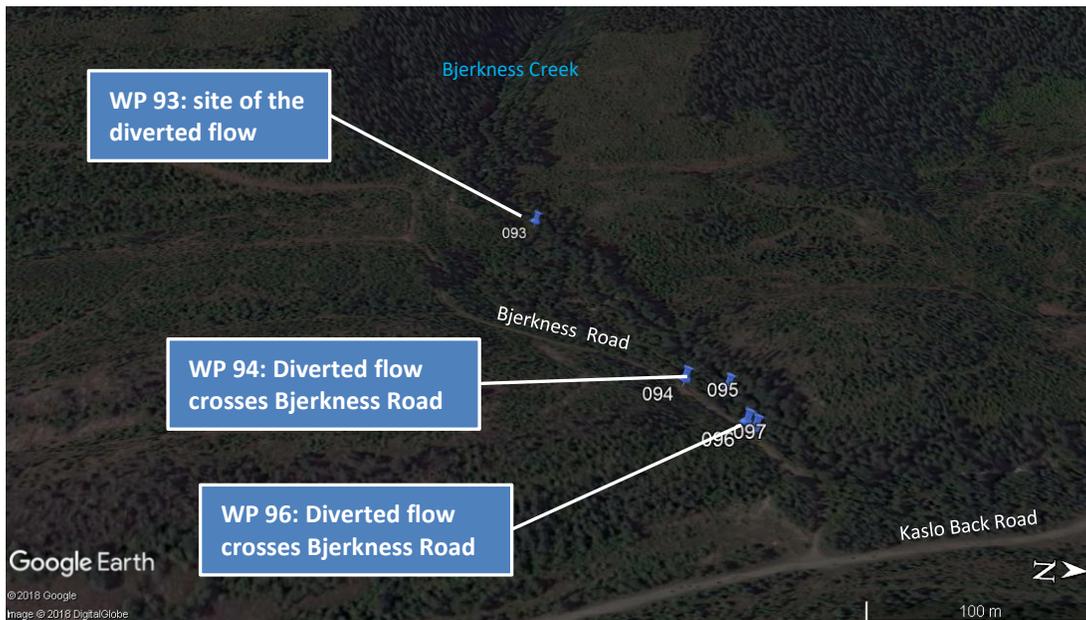
Image 2: Oblique aerial view using GE looking west at the lower reaches of Bjerkness Creek showing the location of the diverted flow and the locations where it crossed the Bjerkness road.

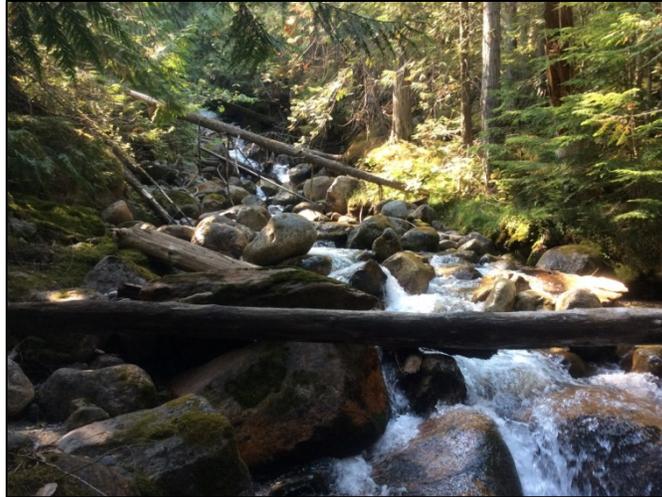
1. Bjerkness Creek breached its main channel at a site located approximately 450 m upstream from the Kaslo Back Road (WP 93). The creek at this site remains confined in a broad gully, 6-7 m wide and the channel bedload consists mainly of boulders, cobbles and coarse woody debris. Channel gradients are 15-20% (refer to Image 3). A portion of the flow eroded through a lobe of what appears to be older debris flow deposits on the right bank resulting in a diversion of the flow into an older, adjacent flood channel confined in a shallow gully located immediately south of the main channel (refer to Images 4 and 5). The cause of the diversion is unknown, but suspect that re-mobilization of the bedload, including large boulders and woody debris, during the spring freshet of 2018 may have been a significant contributing factor. The 2018 snowpack and high stream peak flows recorded above average values.

Image 3: View looking upstream at the Bjerkness Creek channel and the coarse bedload (WP 93).

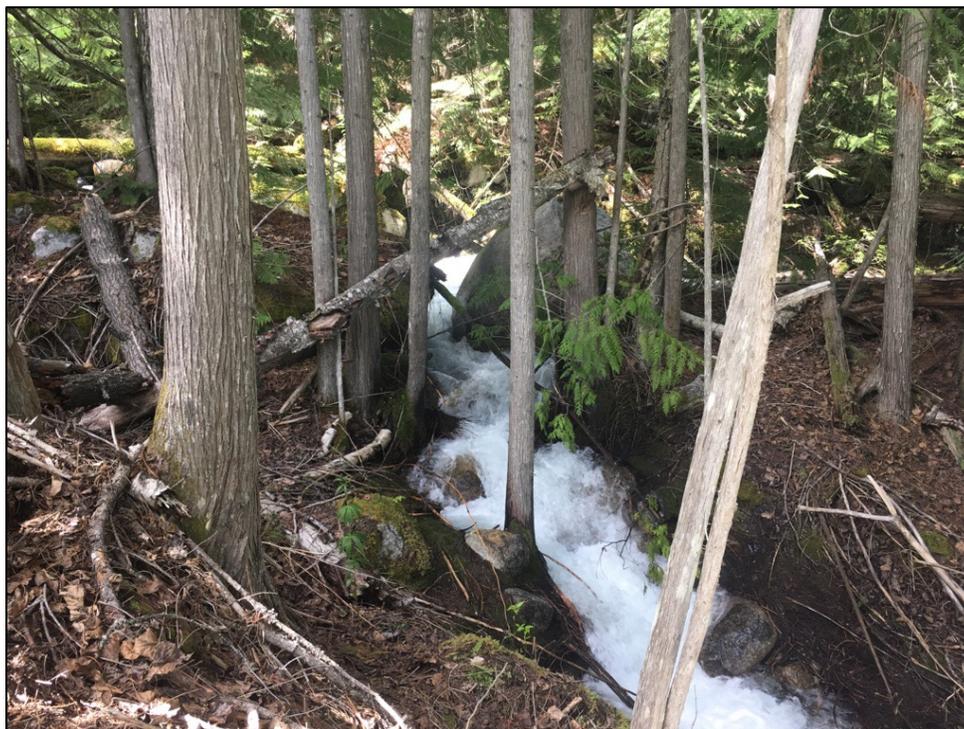
Image 4: View of the site where a portion of the Bjerkness Creek flow was diverted and eroded a channel through old debris flow deposits (WP 93).

1. The option of attempting to redirect the diverted flow into the main Bjerkness Creek at the site where the channel was breached is not recommended. The process would require manual labor and machinery which would be very labor intensive, expensive and hazardous. Given the size of the creek and the significant volumes of water flow during peak flows and the potential mobilization of the coarse bedload material, these types of natural events are likely to occur in the future. Therefore any attempts at modifying the creek channel may be very temporary.
2. The diverted flow is likely to continue its course in the future. Recommended mitigating the issue where the flow affects the Bjerkness road.

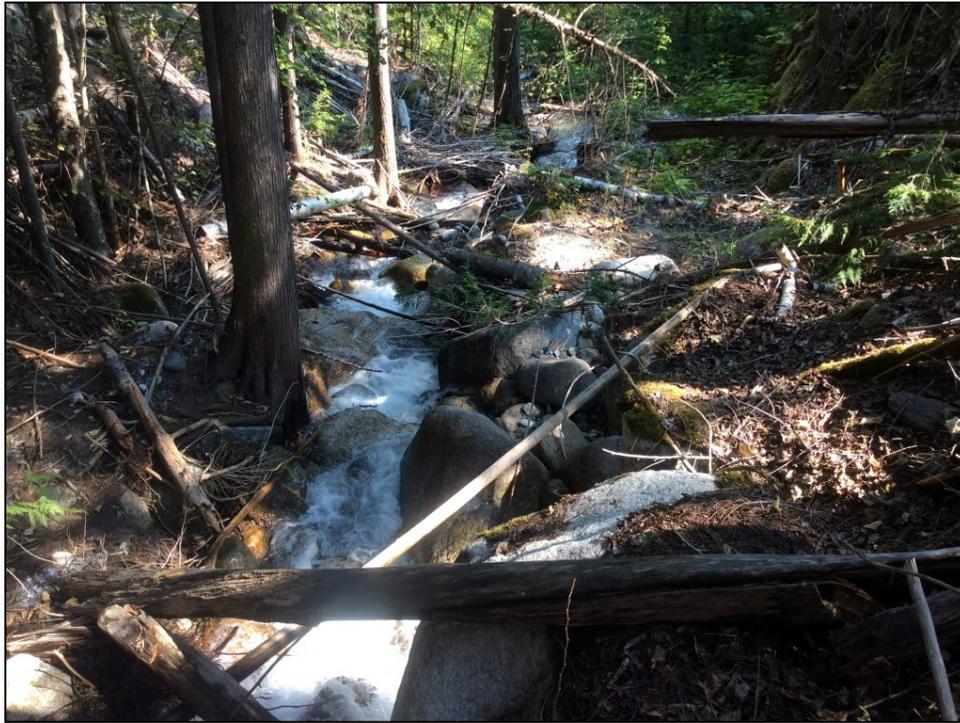
Image 5: View looking down stream at diverted flow entering old flood channel contained in a shallow gully (WP 93).

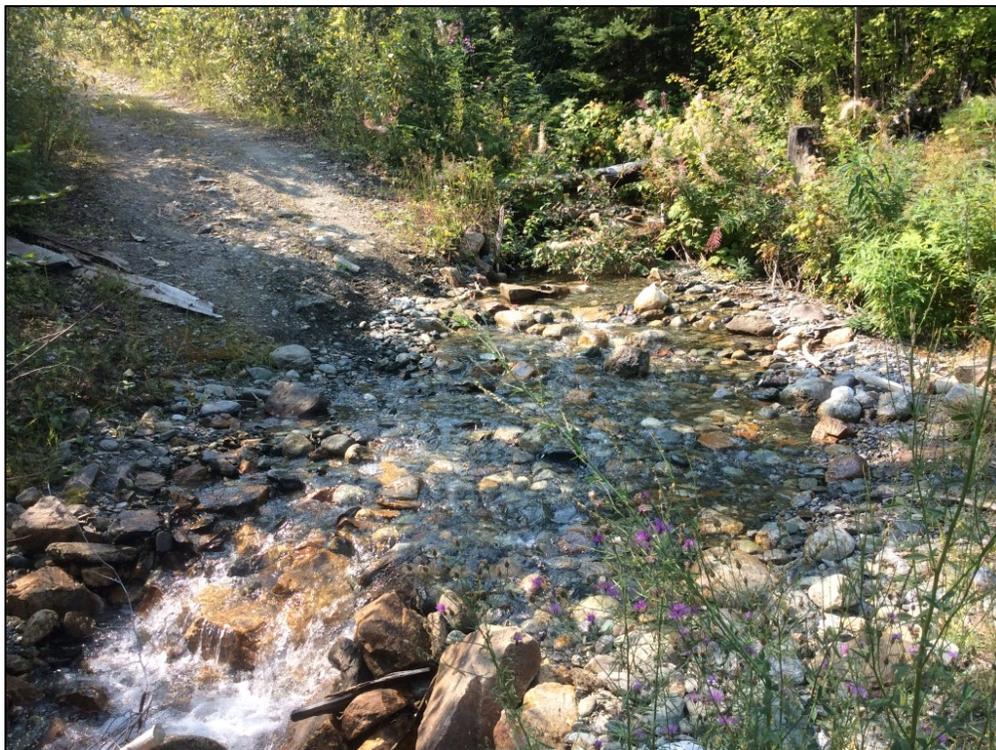
2. The diverted flow remained confined in the shallow gully and flowed approximately 270 m where it became less confined and overflowed and crossed the Bjerkness road (WP 94, refer to Images 6 and 7). This resulted in a portion of the overflow to erode a narrow channel along the north side of the road, creating a ditch, and continued approximately 25 m where it diverted back towards the main Bjerkness Creek channel, located 20 m north (refer to Image 8). The remainder of the diverted flow crossed the road and flowed along the south side the road confined to a shallow swale.

Image 6: View looking up at the first location where the diverted flow crosses the Bjerkness road (WP 94).

1. Option #1: Install 1000 mm culverts at both locations where the diverted flow crossed the Bjerkness road located at WP 94 and WP 96.
2. Option #2: At the site where the diverted flow first crosses the Bjerkness road (WP 94), widen and deepen the eroded channel that forms a ditch for 25 m length. The intent is to intercept the diverted flow prior to crossing the road, maintain the flow in the ditch and divert the flow back into the main channel.
3. WP 97: Install a cross ditch intended to divert any potential overflow off the road and back towards the main channel.

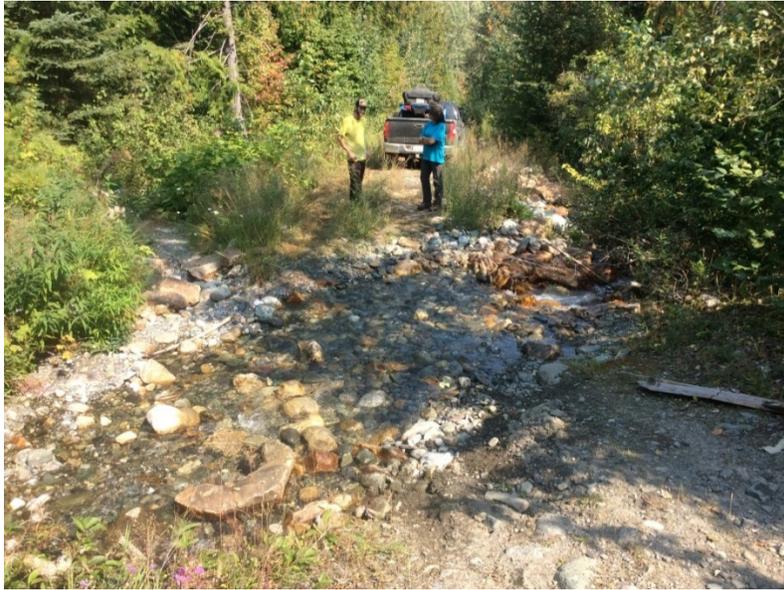
Image 7: View looking down at the first location where the diverted flow crosses the Bjerkness road (WP 94).

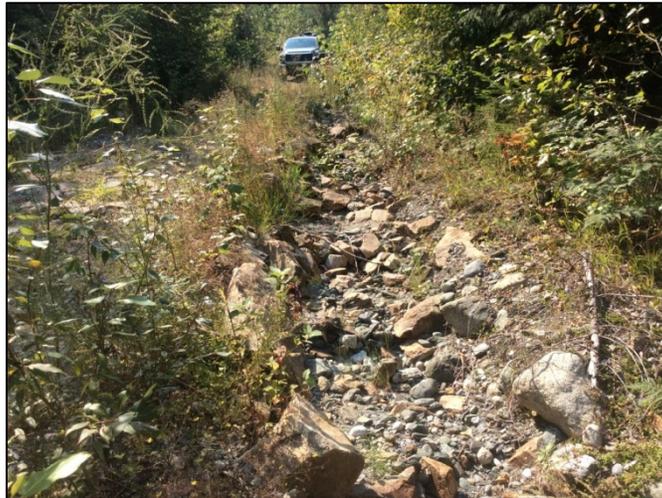
Image 8: View of the eroded channel forming a ditch as a result of the diverted flow (WP 94).

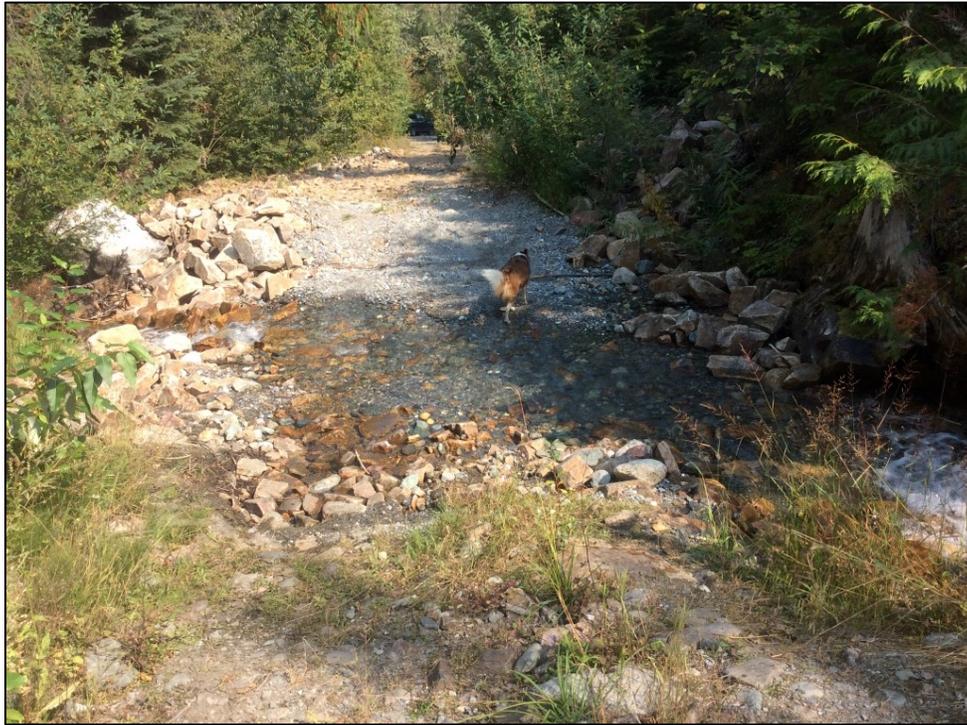
3. The diverted flow confined in the swale alongside the road crossed the road a second time (WP 96) resulting in the flow to continue down the Bjerkness road, eroding the road surface and impacting the Kaslo Back Road located approximately 125 m down the road. This event was followed up by some maintenance and mitigation measures by the local public works which included installing a ditch at the crossing and re-surfacing the road with coarse free-draining material (refer to Image 9).

Image 9: View looking down at the second location where the diverted flow crosses the Bjerkness road (WP 96). The image shows the repairs to the road following the diversion of the flow down the road towards the Kaslo Back Road.
