**Terrain Interpretation  
of operating areas for  
Kaslo Community Forest Licence,  
Woodlot 494, and Goose Creek Timber Ltd.**

**Report with Maps  
for the licencees and  
Kootenay Lake Forest District**

**Terrain Classification with interpretations for:  
Terrain Stability Hazard,  
Surface Erosion Hazard  
Road & Ditch Erosion Hazard  
Landslide Induced Stream Sedimentation Hazard  
Sediment Delivery Potential  
Sediment Yield Potential**

**Co-authors:  
W. H. Wells, PAg. and C. Wallace, P. Geo.,**

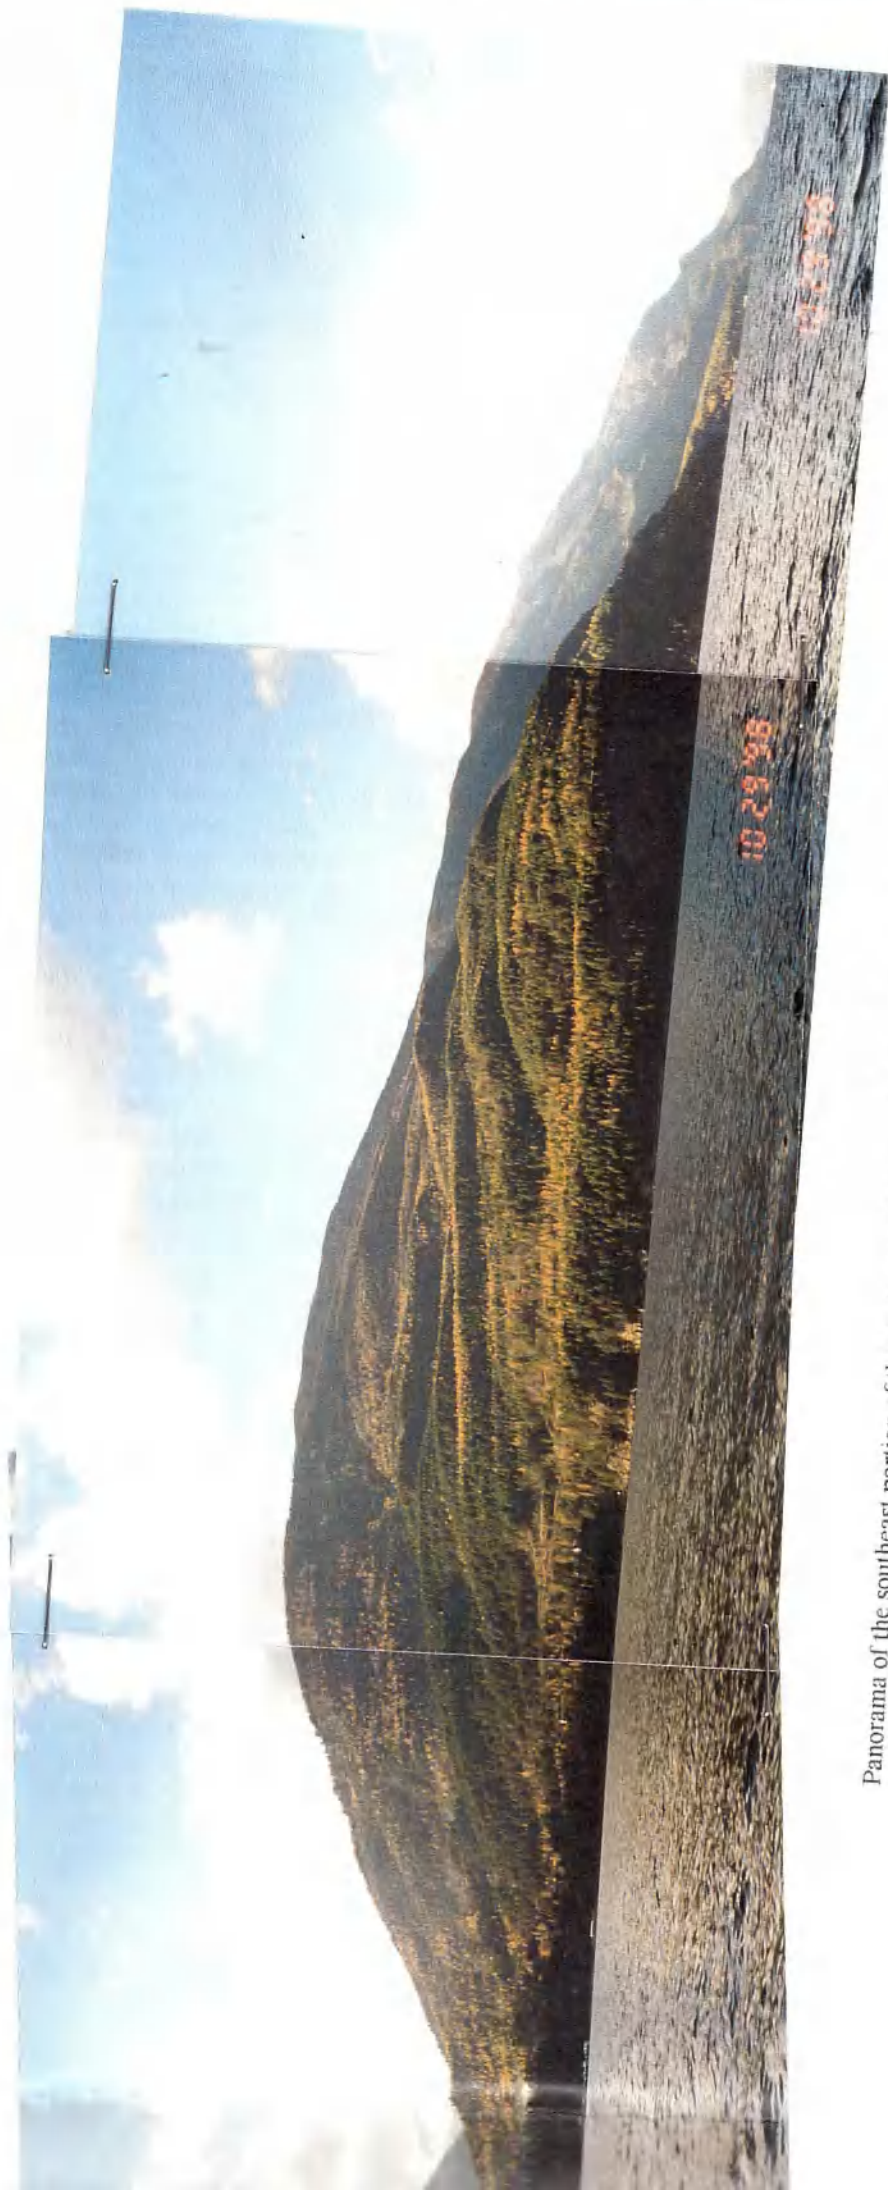
Panorama of the southeast portion of the study area. Ridged and fluted surface shape reflects the underlying geology.
