Zwicky Road Landslide Site Assessment, Kaslo, BC, 18 April 2017

Sarah Crookshanks, P.Geo. (MFLNRO)

Peter Jordan, P.Geo. (SNT Geotechnical Ltd.)

April 20, 2017

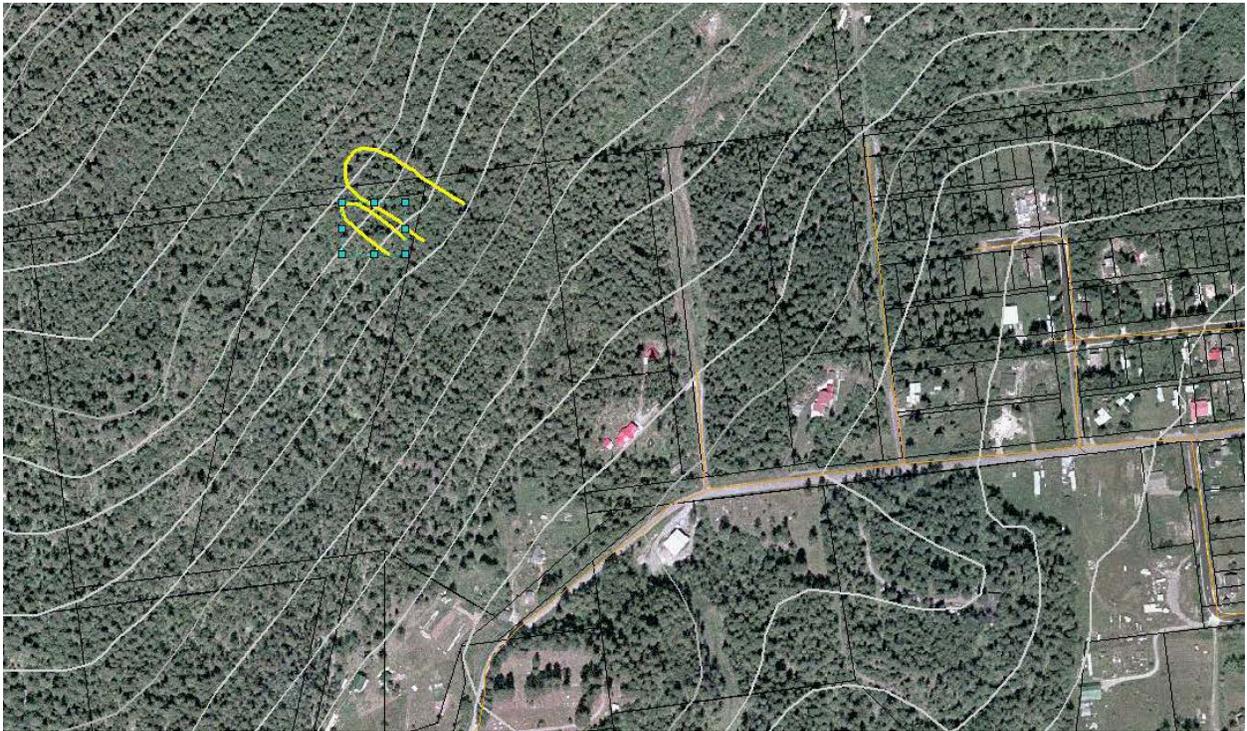
Figure 2. Location of the landslide (in yellow) above Zwicky Road in Kaslo. Contour lines are at 20 m intervals. The headscarp of the northeast slide is at approximately 890 m.
